Arlington Townhomes

Construction Drainage Report

Tic Toc, LLC
3226 256th St NW
Stanwood, WA 98292

LDC | Surveying
Engineering
Planning
20210 142nd Ave NE
Woodinville, WA 98072
(425) 806-1869

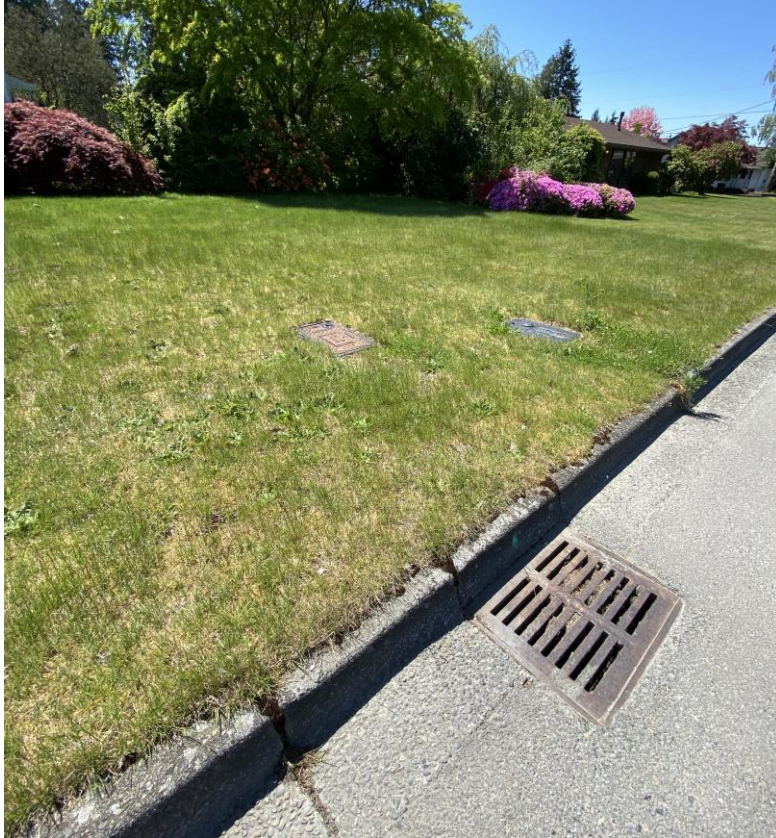
Image ① E Highland Dr Frontage Catch Basin. Onsite flows flow away from frontage

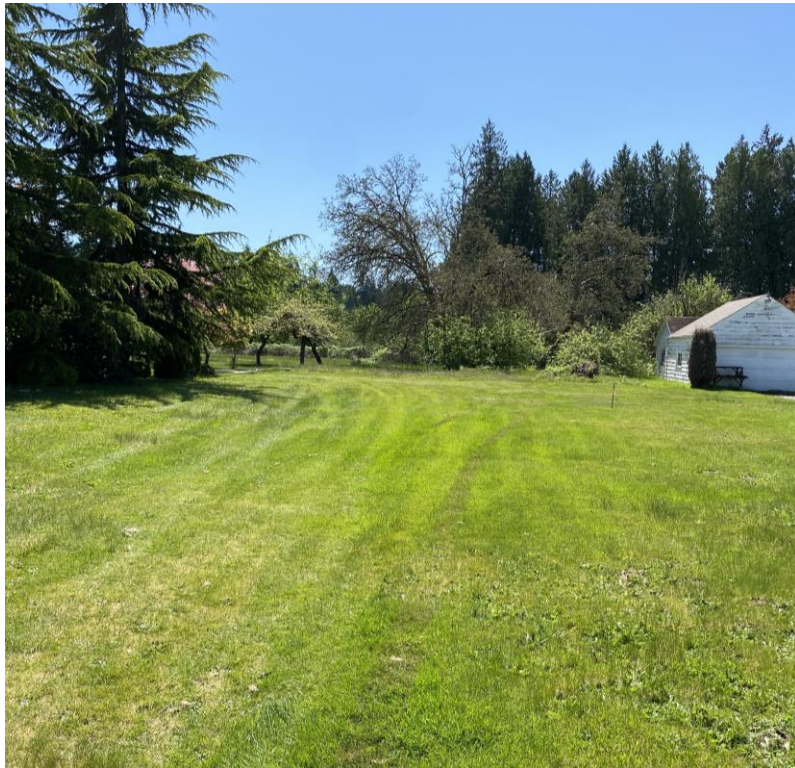
Image ② Onsite looking east. Flows travel overland eastward.

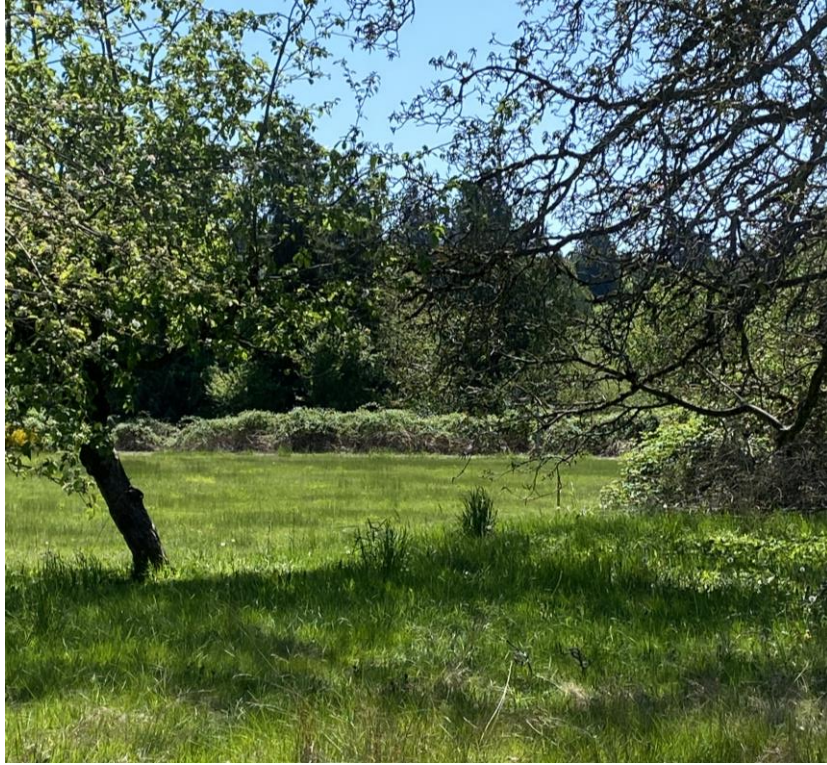
Image ③ Towards the back of the property looking east at blackberry bush overgrowth there site slopes

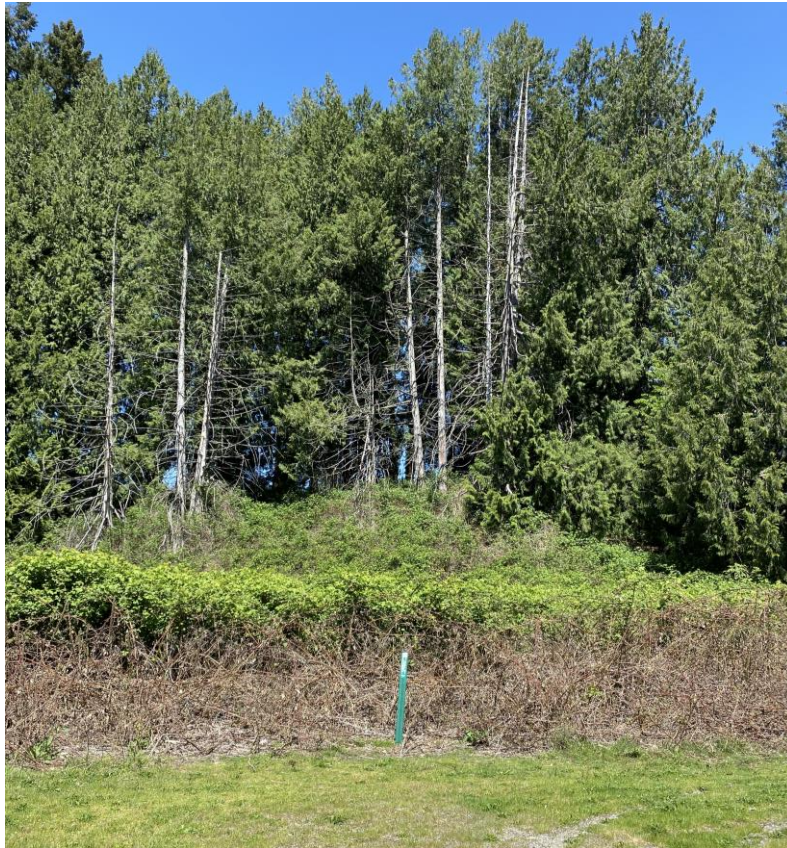
Image ④ Photo on adjacent property looking west to property where heavy bushes and sloping is present

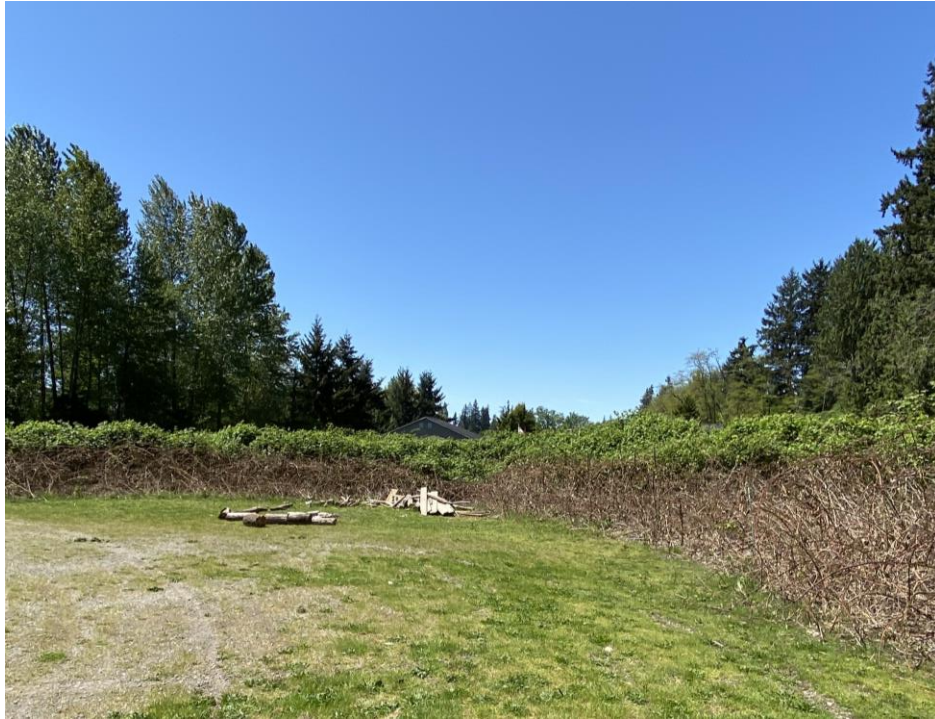
Image ⑤ Flows continue overland west through heavy shrubbery (right to left)

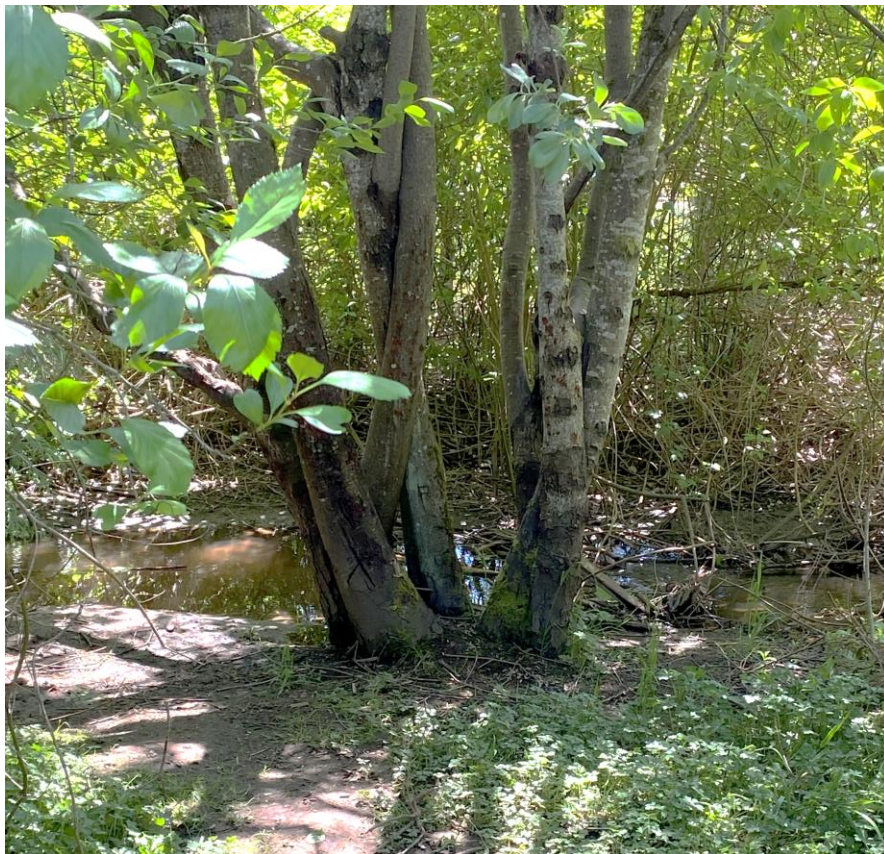
Image ⑥ Flows continue into an unnamed stream west
